X The objective of Project 1.8b was to investigate the blast damage sustained by drag-sensitive targets when the blast wave passes over rough, hilly terrain to the target location. Of particular interest was the difference in the damage sustained by those targets which were positioned to take maximum advantage of terrain irregularities and the damage sustained by those targets placed over level terrain at corresponding distances.

This report presents the final results of one of the 46 projects comprising the military-effect program of Operation Plumbbob, which included 24 test detonations at the Nevada Test Site in 1957.

EFFECTS of ROUGH TERRAIN on DRAG-SENSITIVE TARGETS

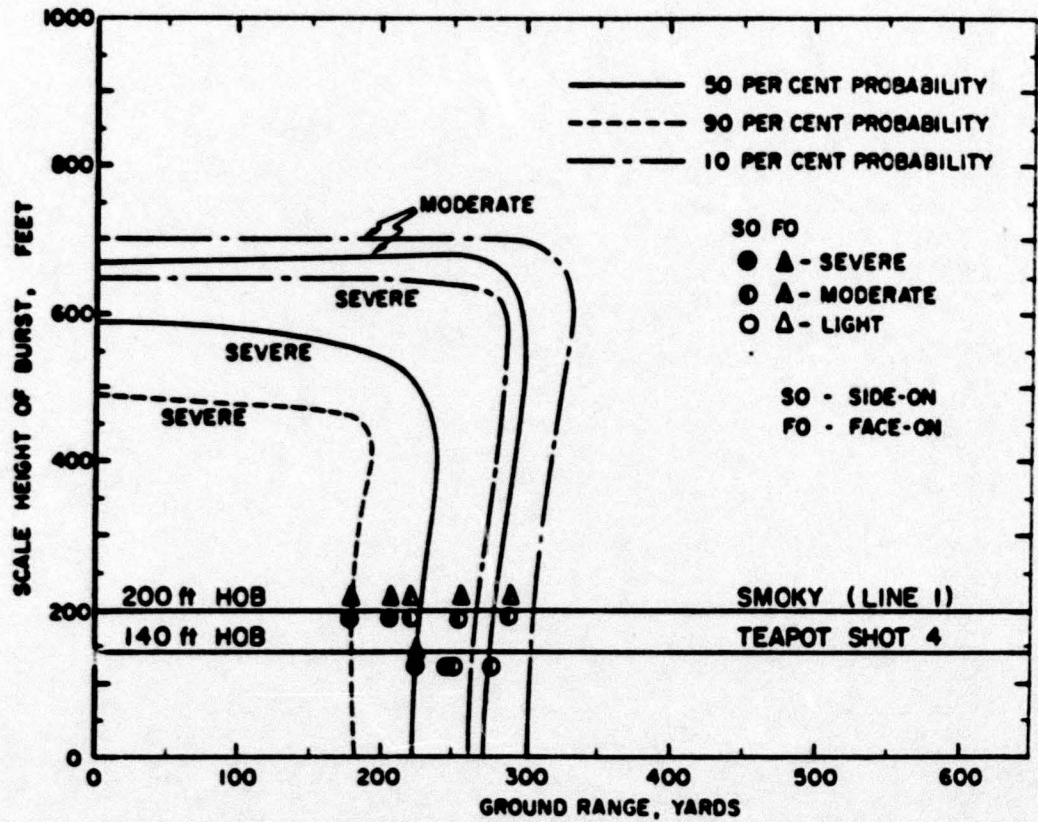
Figure 12 Comparison of Smoky Line 1 with Teapot Shot 4 and the Damage Chart of TM 23-200 scaled to 1 kt.

Figure 12 compares the damage sustained by the vehicle stations along the control line with that predicted by the TM 23-200 vehicle-damage chart. Data from another NTS shot of the same yield (Teapot, Shot 4, 43 kt at a height of burst of 500 feet is also plotted on this chart. The comparisons show that the control line results were typical for an NTS shot over level terrain both with respect to the TM 23-200 damage chart and the NTS shot of similar yield. (Note: The TM 23-200 chart was revised since this data was compiled; however, the revised material, at the height of interest, was only slightly altered.)

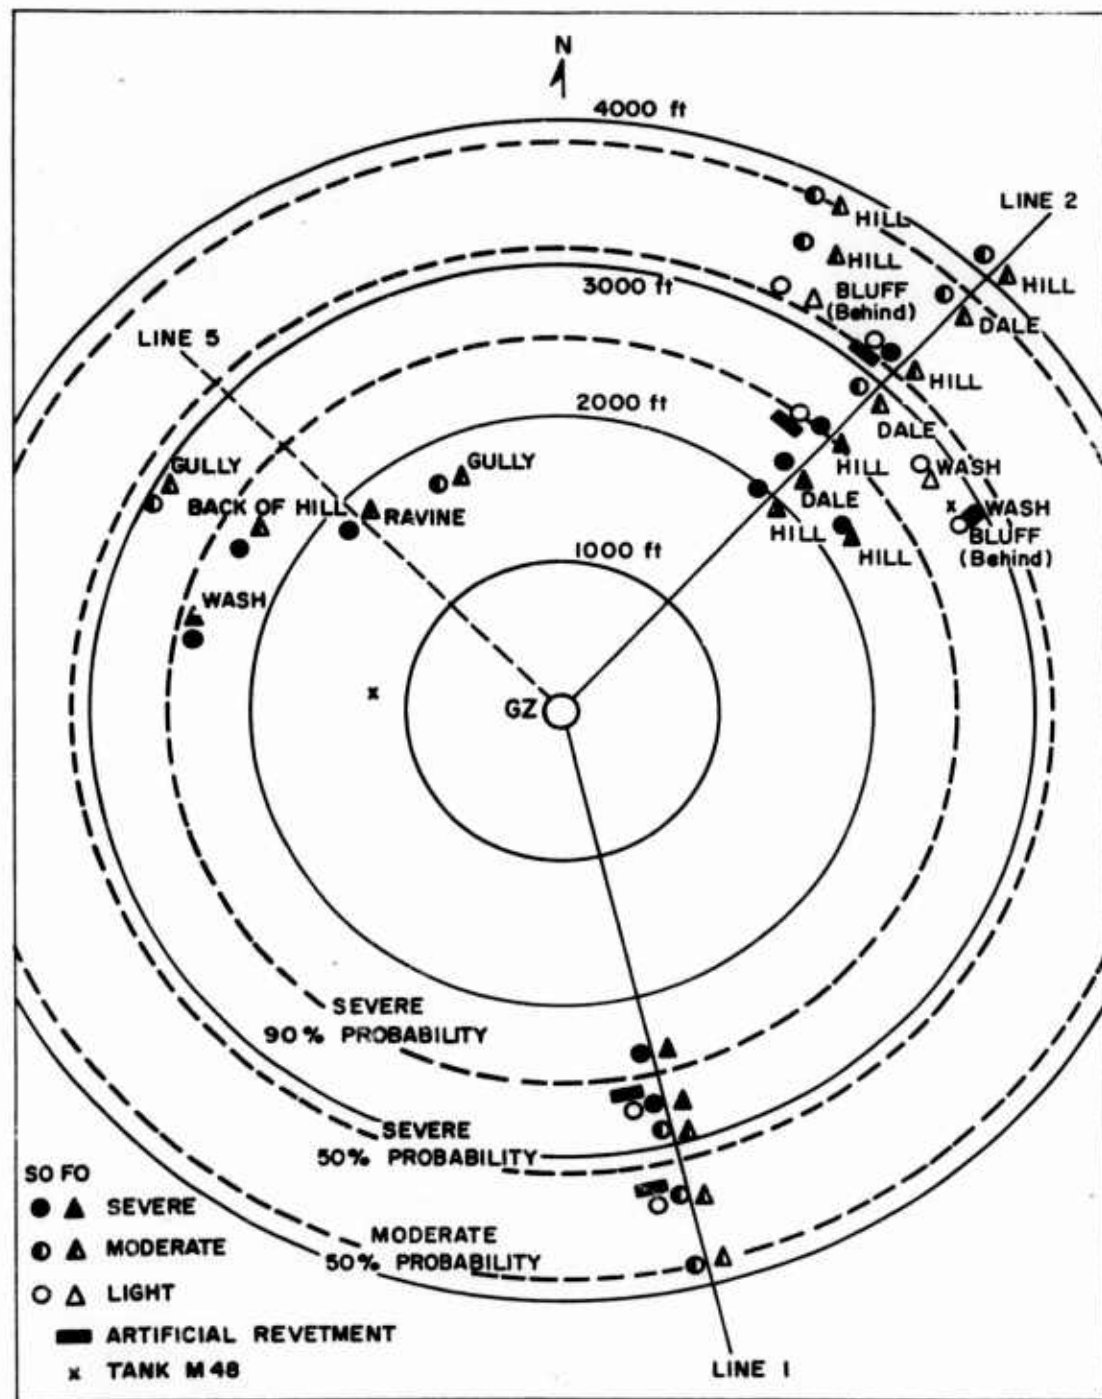
Figure 13 Layout of vehicle stations and resulting damage for Shot Smoky.

Figure 13 shows the damage sustained by all vehicle stations and designates the type of terrain at the station location. This information is shown on a polar plot in order that the various stations can be compared directly. The damage probability contours of TM 23-200 have been scaled to shot conditions and are shown in Figure 13 so that comparisons of actual and predicted damage can be made.

As shown in Figure 13, the damage experienced by the vehicles directly on Line 2 was identical at corresponding distances on the control line, with one exception. The side-on vehicle at Station 6.09 (a hill station) was severely damaged, while the vehicles in front of this station, as well as those equal distances on the control line, were only moderately damaged. Although severe damage is implied at this ground range, it is unusual to have those vehicles (surrounding and preceding the severely damaged vehicle) sustain only moderate damage.

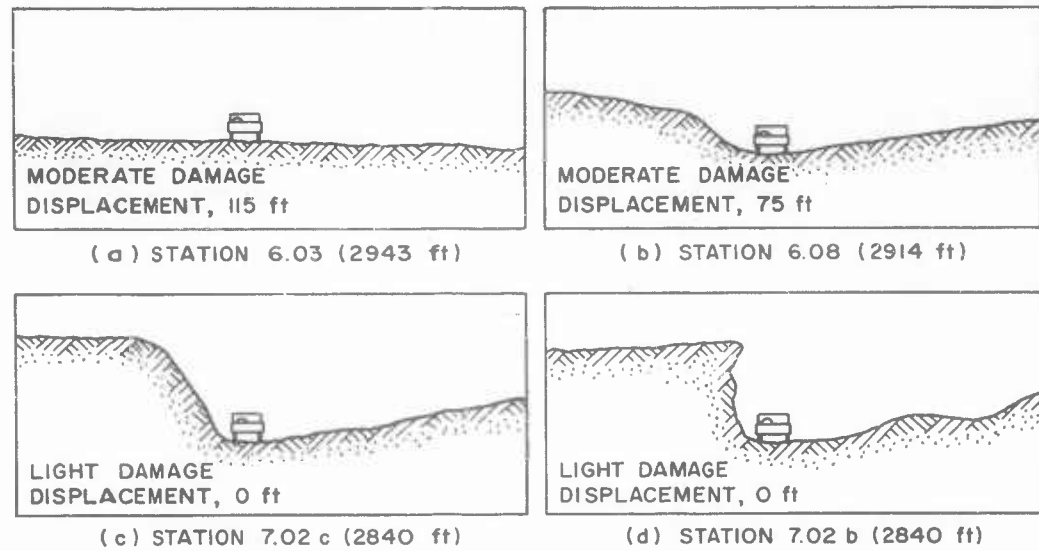
Figure 14 Terrain profiles for vehicle stations.

The comparison of Stations 6.03, 6.08, and 7.02 in Figure 14 shows that, at about the same ground range, significant reduction in damage was obtained when proper advantage was taken of existing terrain accidents. The vehicle at Station 6.03 (2,943 feet) on the control line was displaced 115 feet, sustained moderate damage, and would have required about 12 hours of maintenance work to restore to combat usability. The corresponding vehicle at Station 6.08 (2,914 feet) on Line 2 was displaced 75 feet and sustained moderate damage requiring 4 hours maintenance time. Those vehicles at Stations 7.02a and 7.02b were not displaced and only lightly damaged, requiring no repair time.
